AA-305
Spriggs-Lamb House
Arnold

INVENTORY FORM FOR STATE HISTORIC SITES SURVEY

Spriggs-Lamb House

938 Lynch Drive, off of Bayberry Drive

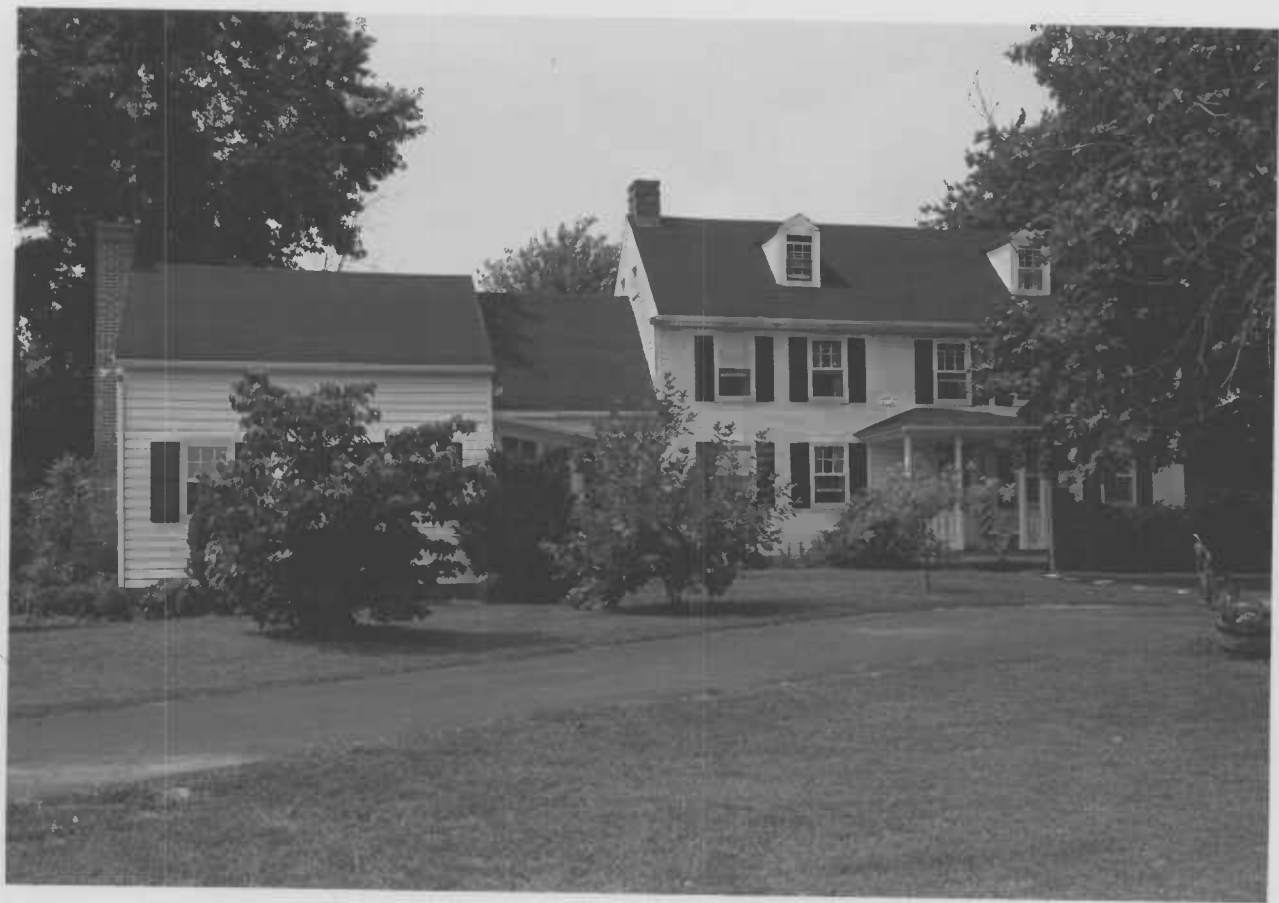
AA-305

A hipped roof entrance porch, having perforated balusters, chamfered posts and uneven bays, shelters the front door, north elevation.

The entrance door is in the center bay, front elevation of the main block. The door has six panels and a small rectangular transom above it. The summer kitchen has a door in the center bay

All of the windows on the house have 6/6 light double hung sash. On the north elevation, main block, there is a wide interval between the first two and the last three bays, which corresponds to the staircase within. The kitchen and summer kitchen have smaller scale 6/6 light sash.

North elev.
